**INVESTIGATION OF TENSION-COMPRESSION FATIGUE
BEHAVIOR OF A CROSS-PLY METAL MATRIX
COMPOSITE AT ROOM AND ELEVATED TEMPERATURES**

THESIS

Presented to the Faculty of the Graduate School of Engineering
of the Air Force Institute of Technology

In Partial Fulfillment of the
Requirements for the Degree of
Master of Science in Aeronautical Engineering

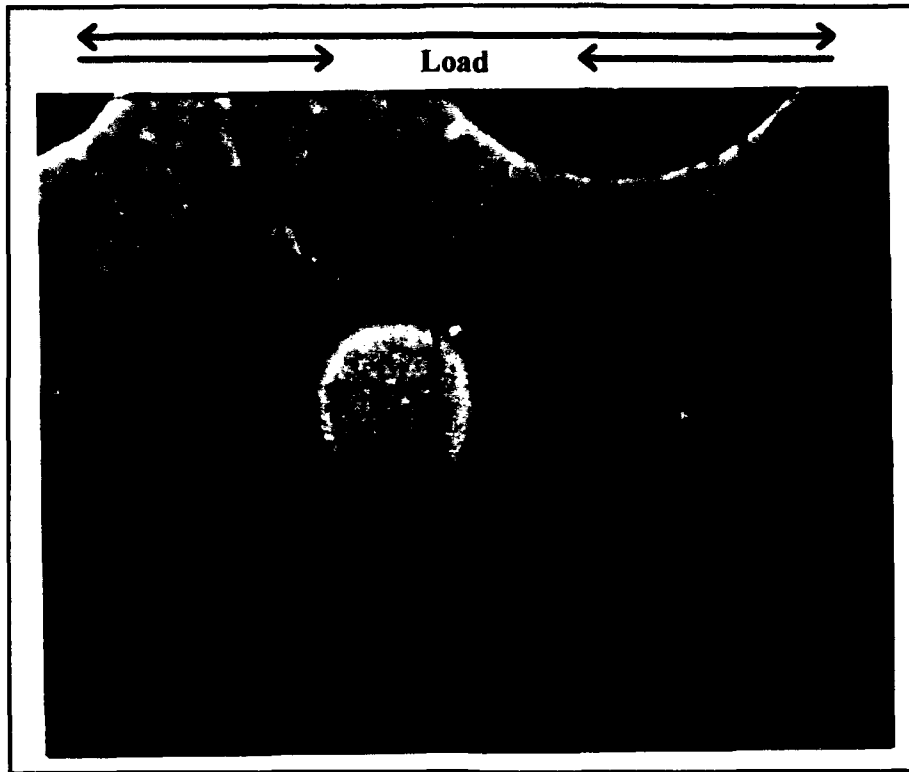
Figure 29. 600 TC RT: Debonded, Broken 0° Fiber Causes Matrix Cracking (200x)

Examination of sectioned specimens reinforced the damage progression as seen in the edge replica evaluation. In addition, the post heat treatment, which was performed after testing and prior to sectioning, highlighted the areas and extent of plasticity *within* the specimen. This post heat treatment causes the very fine α phase of the matrix to

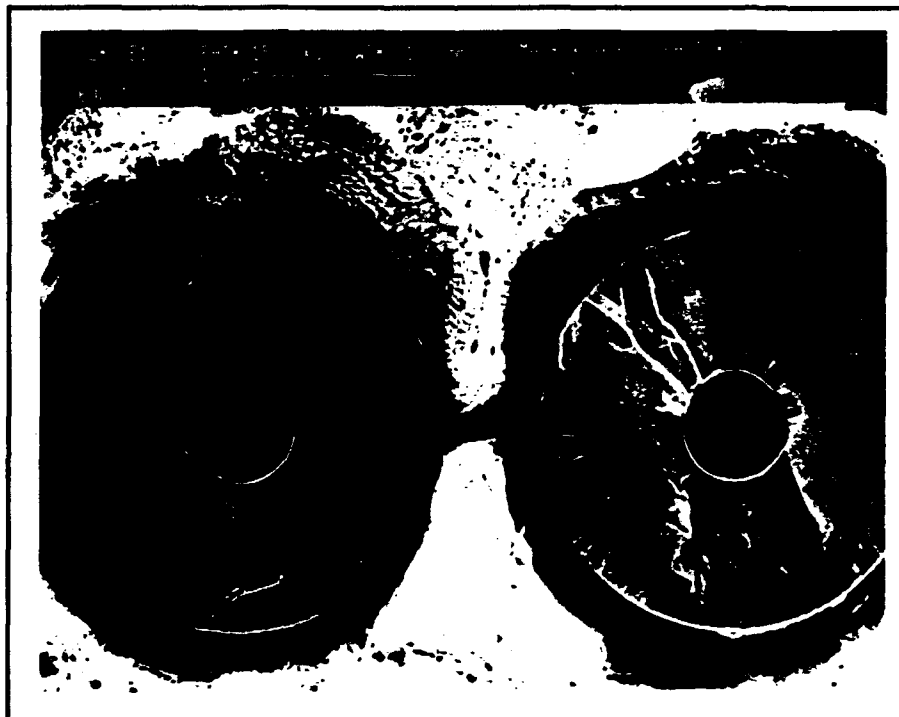
Figure 33. 600 TC RT: Fracture Surface (369x)

Examination of the fracture surface revealed a combination of brittle cleavage and ductile void coalescence, the latter being more predominant. This highly dimpled surface (Fig. 33) is indicative of a fiber-dominated tensile overload type failure. Additionally, the fracture occurred on several different 90° layers within the specimen. This is due to the fact that the large amount of fiber failure which dominates Regime 1 occurs sporadically within the specimen, without regard to a certain plane. This is in direct contrast to a highly *matrix* dominated failure which usually occurs on the plane of the dominant matrix crack. The fracture surface also revealed that many of the 90° fibers were broken through the middle, indicating that the compressive loads caused radial fiber cracking.

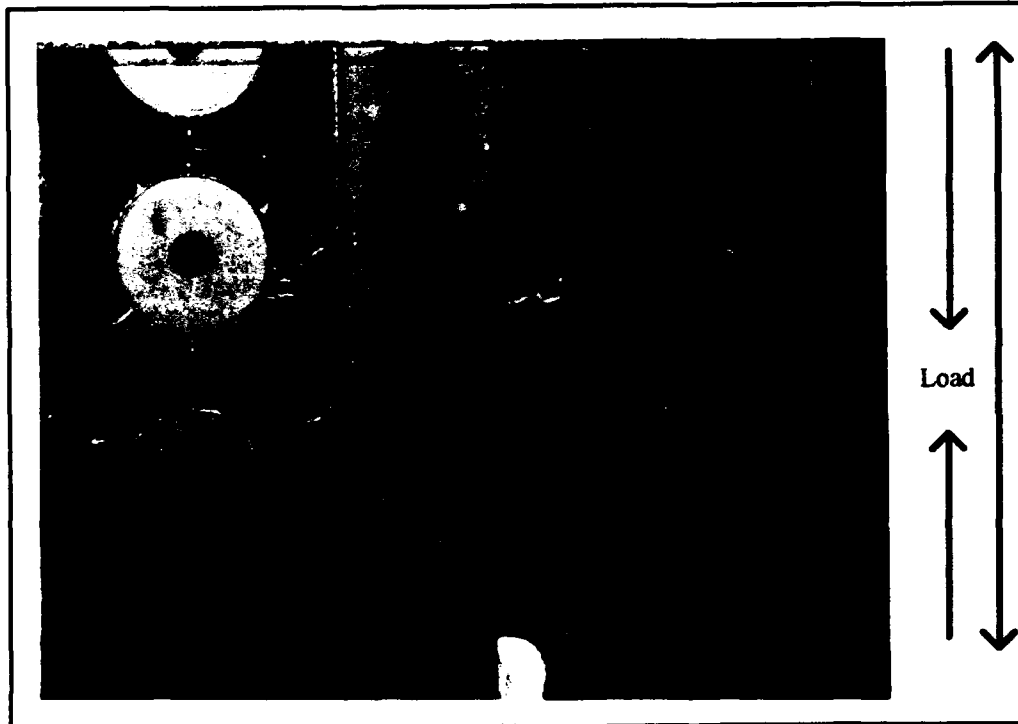
Figure 35. 300 TC RT: Crack Bridging Around a 0° Fiber (150x)

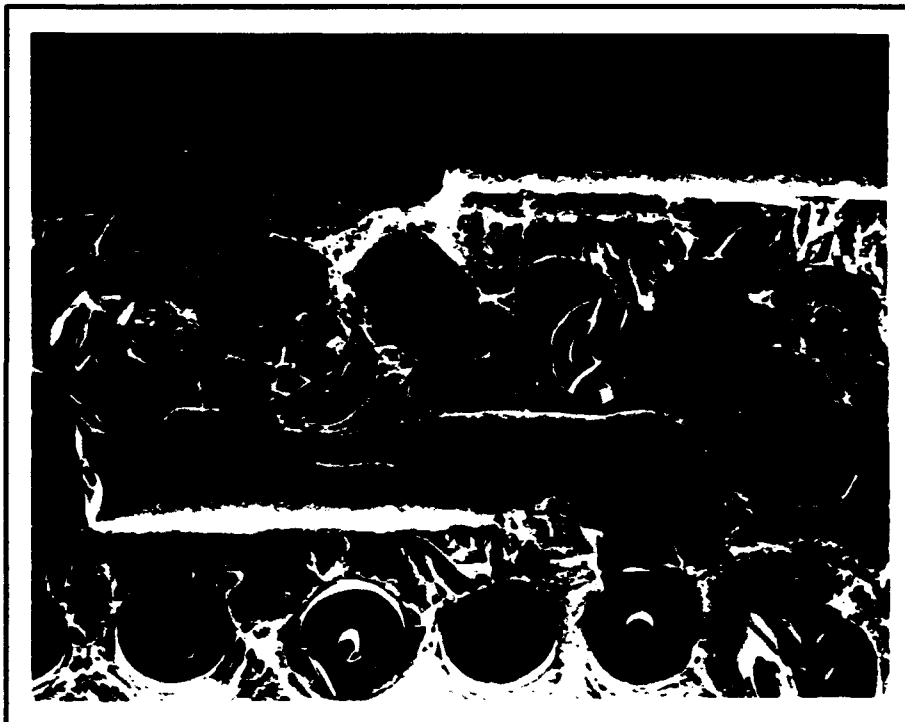
Figure 38. 445 TC RT: Micro-buckling of 0° Fibers (100x)

Further examination of the fracture surface of the 445 MPa test also revealed that micro-buckling of the fibers may have occurred. In general, when fibrous composites are subjected to compressive stresses, the fibers act as long columns, and can buckle due to the compressive loads well before, or in the absence of, overall buckling of the specimen. Additionally, if these fibers have debonded from the matrix, they lose a significant amount of the strength and support it initially imparted. Added to this is the fact that in this test,

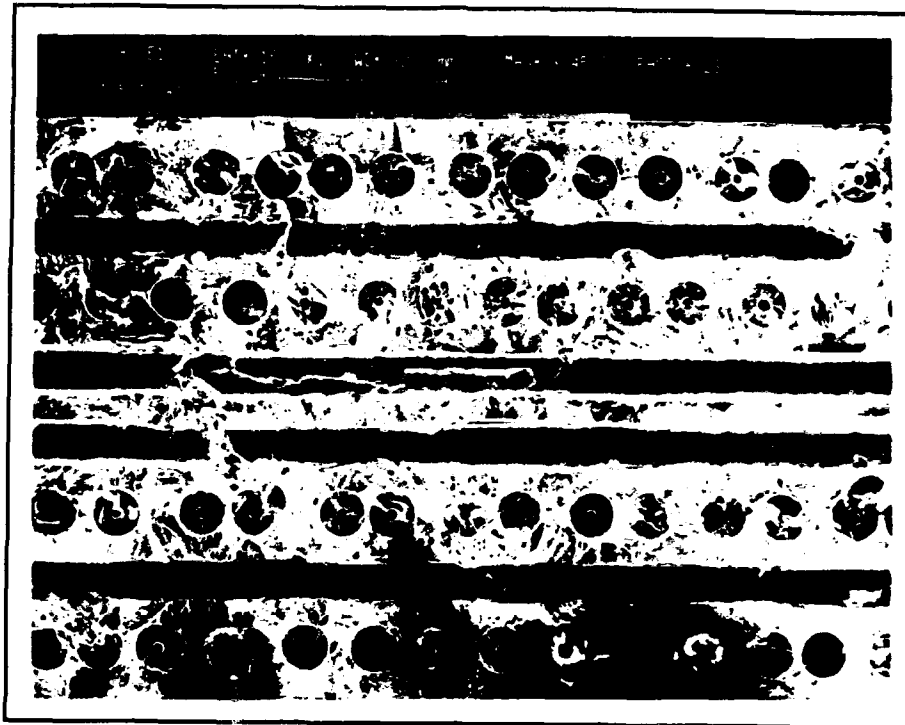
Figure 41. 175 TC RT: Fracture Surface (45x)

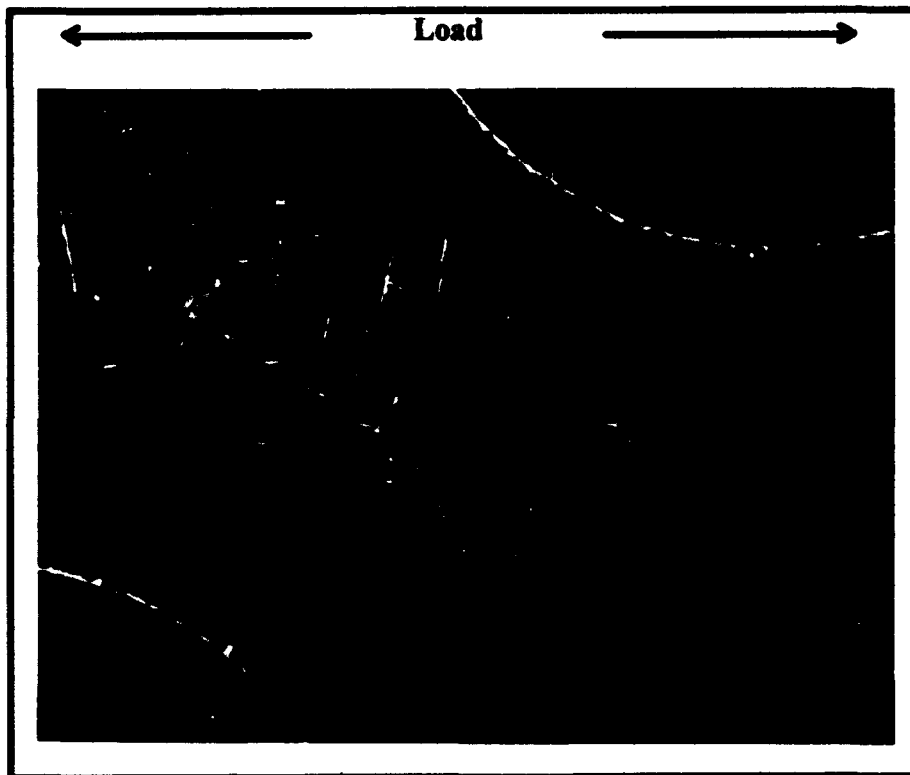
Figure 50. 600 TT RT: 90° RZCs Nucleate Matrix Damage and Plasticity (750x)

showed that many of the 0° fibers were broken, however, none of the observed fiber breaks appeared to cause matrix cracking. The matrix cracking that did exist, without exception, nucleated at rzcs, and coexisted with matrix plasticity. Figure 50 shows two 90° fibers in which rzcs have caused matrix cracks to form. In turn, these matrix cracks have nucleated slip within the matrix. Of particular interest in this picture is that the rzcs are seen to not only cause cracking within the matrix, but appear to be causing a more extensive debond of the 90° fibers. In contrast to the more common debonding which occurs between the reaction zone and the outer carbon silicon layers of the fiber, the rzcs are causing debonding on an additional layer, between the carbon/silicon layers coating and the bulk silicon carbide (see Fig. 6). Evidence of extensive amounts of rzcs on the fracture edge (Fig. 51) further emphasize that they play an important role on the initiation of deformation during fatigue loading.

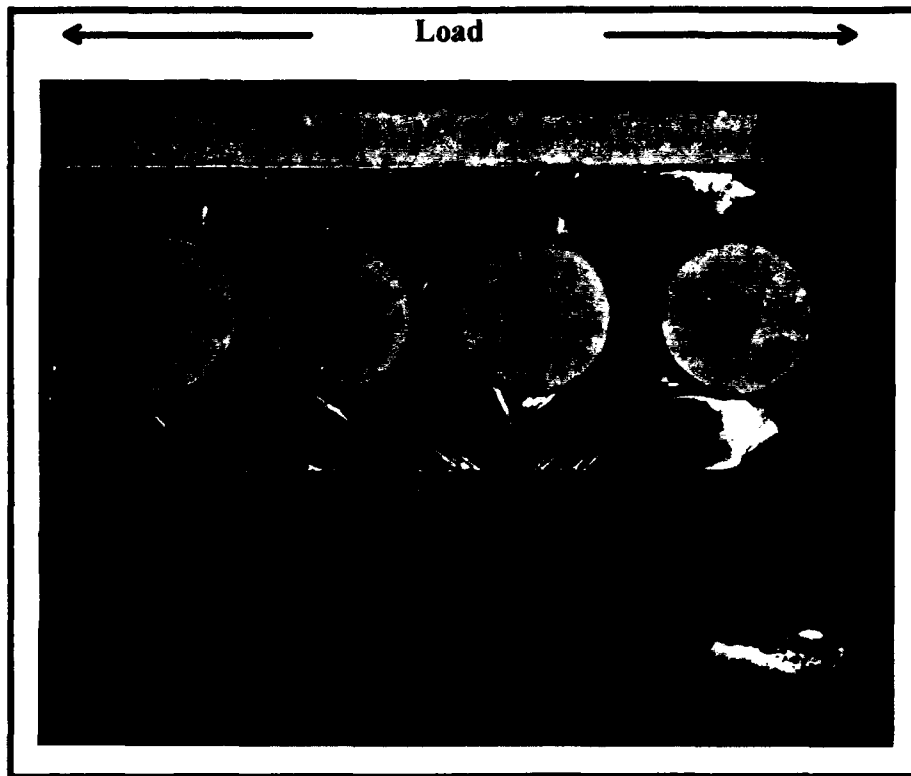
Figure 52. 600 TT RT: Matrix Plasticity and Necking Between Fibers (150 x)

However, matrix plasticity often existed in the absence of matrix cracking, nucleating from both 90° and 0° fibers. Figure 52 shows a portion of a longitudinal section at the fracture surface, in which several types of deformation are evident. The 90° fibers are slightly debonded, and contain rzcs (the rzcs are more evident at higher magnification). The rzcs have nucleated slip bands, but as mentioned above, matrix cracking has not yet occurred. Both 0° fibers have debonded, and the matrix between these fibers and the 90° fiber between the two appears to have necked. Since, in general, debonding occurred on the top and bottom of the 90° fibers, the debonding on the *side* of the 90° fibers further away from the fracture surface, coupled with the debonding of the adjacent 0° fiber, is also evidence that the matrix necked under the tensile load.

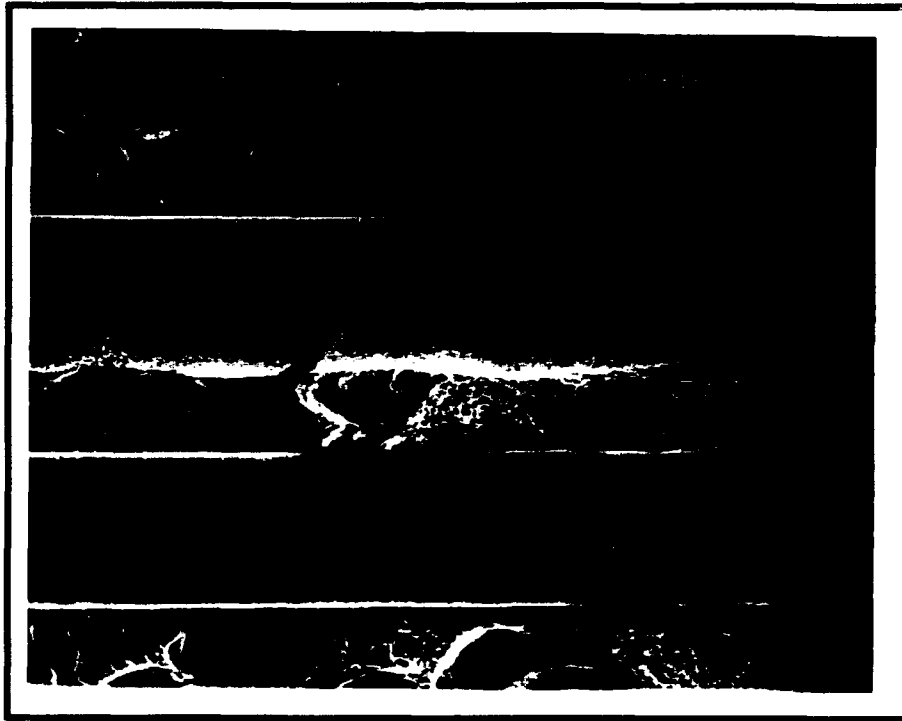
Figure 59. 450 TT RT: Mixed Mode Failure (150x)

Examination of the fracture surface reveals that a mixed mode failure occurred. The increased amount of flat, or cleavage, areas make it evident that much more matrix cracking occurred in this test than in the Regime 1 test. In addition, the multi-leveled fracture surface in conjunction with the many dimpled areas also reveal that some pre-failure fiber damage occurred during the specimen life (Figs. 58 and 59).

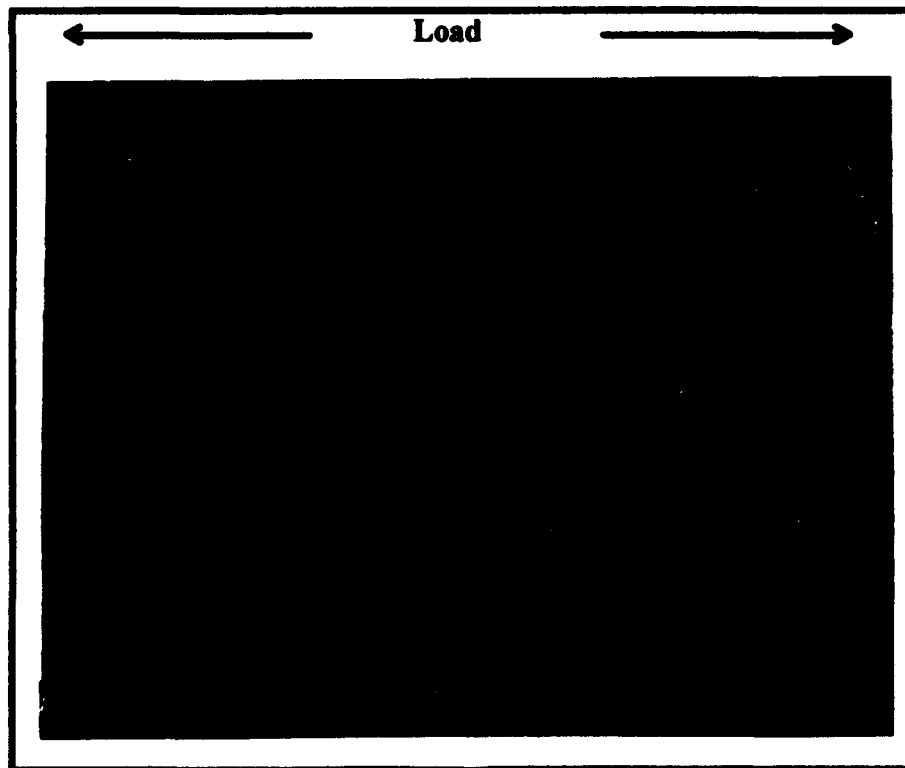
Figure 64. 200 TT RT: RZC Induced Matrix Plasticity (752x)

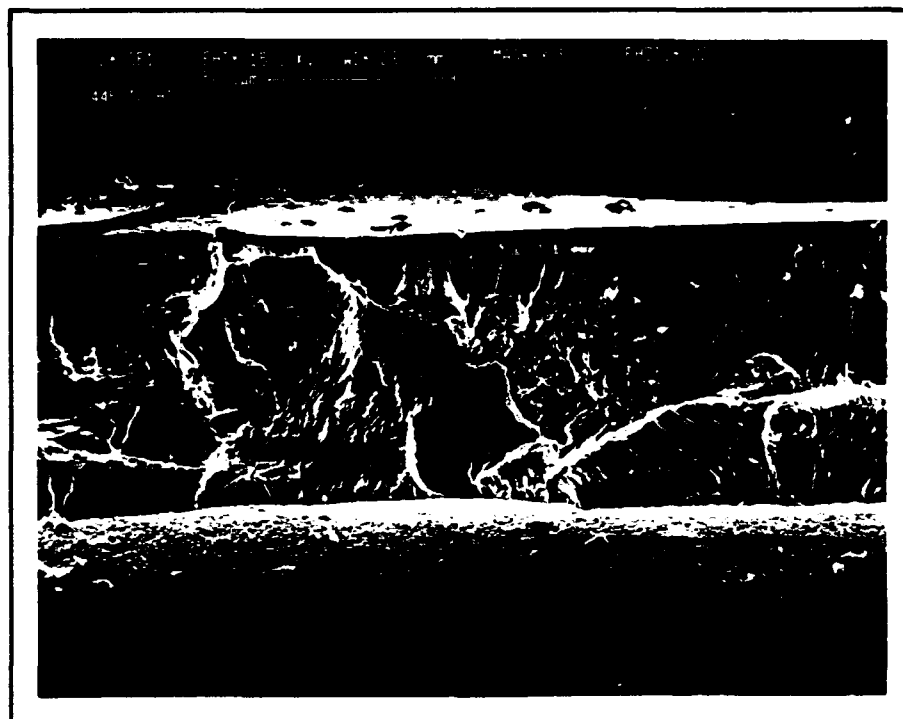
Figure 76. 445 TC HT: Striations on Fracture Surface Between 90° Fibers (500x)

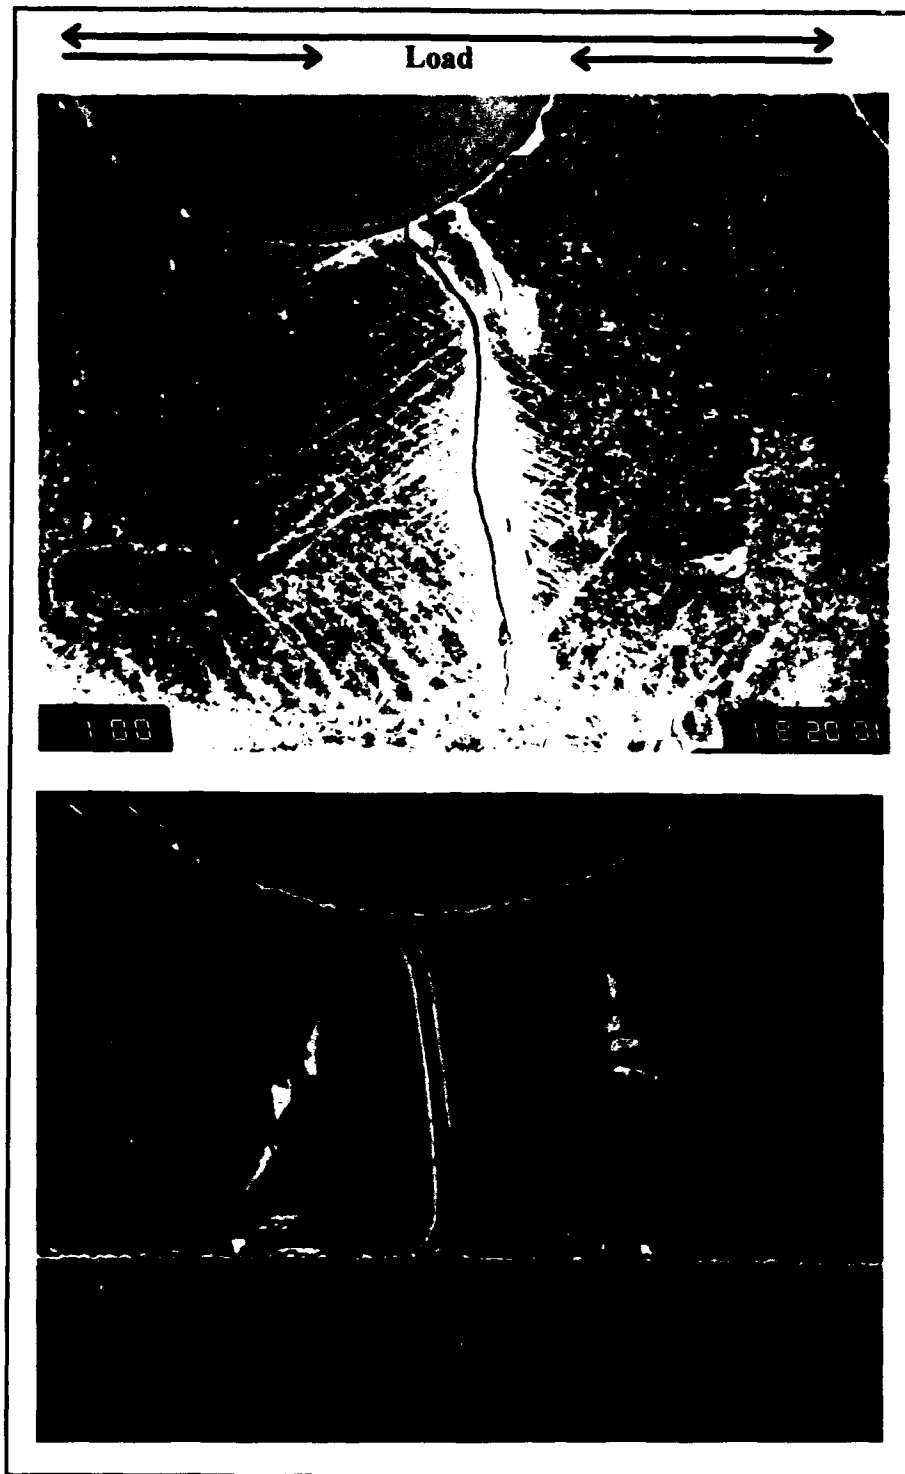
Figure 94. Planar vs. Diffused Slip, 445 TC RT (top) and 370 TC HT (bottom)
